DEPARTMENT OF TRANSPORTATION

Contract #: 04-0120F4Cty: SF/ALA Rte: 80 PM: 13.2/13.9File #: 69.28**WELDING INSPECTION REPORT****Resident Engineer:**Pursell, Gary**Address:** 333 Burma Road**City:** Oakland, CA 94607**Report No:** WIR-015144**Date Inspected:** 01-Jun-2010**Project Name:** SAS Superstructure**OSM Arrival Time:** 700**Prime Contractor:** American Bridge/Fluor Enterprises, a JV**OSM Departure Time:** 1900**Contractor:** Zhenhua Port Machinery Company, Ltd (ZPMC), Changxing Island **Location:** Shanghai, China

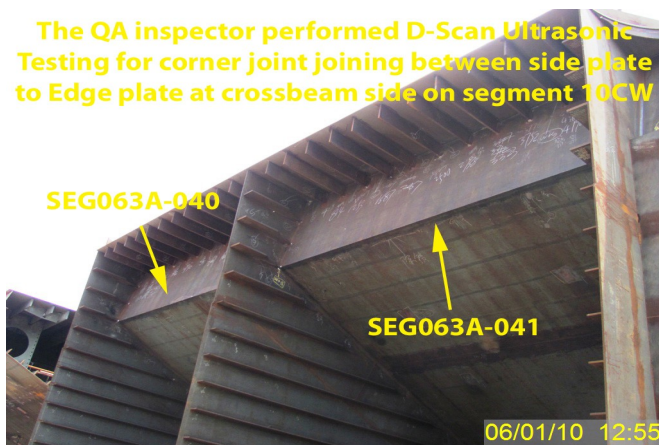
This QA Inspector performed Ultrasonic testing (UT) 10% of the area previously tested and accepted by ZPMC Quality control personnel. This QA inspector generated a (UT) report for this date. The members are identified as portion corner joint between Side plate to Edge Plate of segment 10CW. According to rejection criteria of "D" Scan procedure that Caltrans QA did not find any Rejected indication at scanning area.

The QA inspector performed D-Scan Ultrasonic Testing for corner joint joining between side plate to Edge plate at crossbeam side on segment 10CW
